Craumer House

BA - 1448

INVENTORY FORM FOR STATE HISTORIC SITES SURVEY

37 Allegheny Avenue

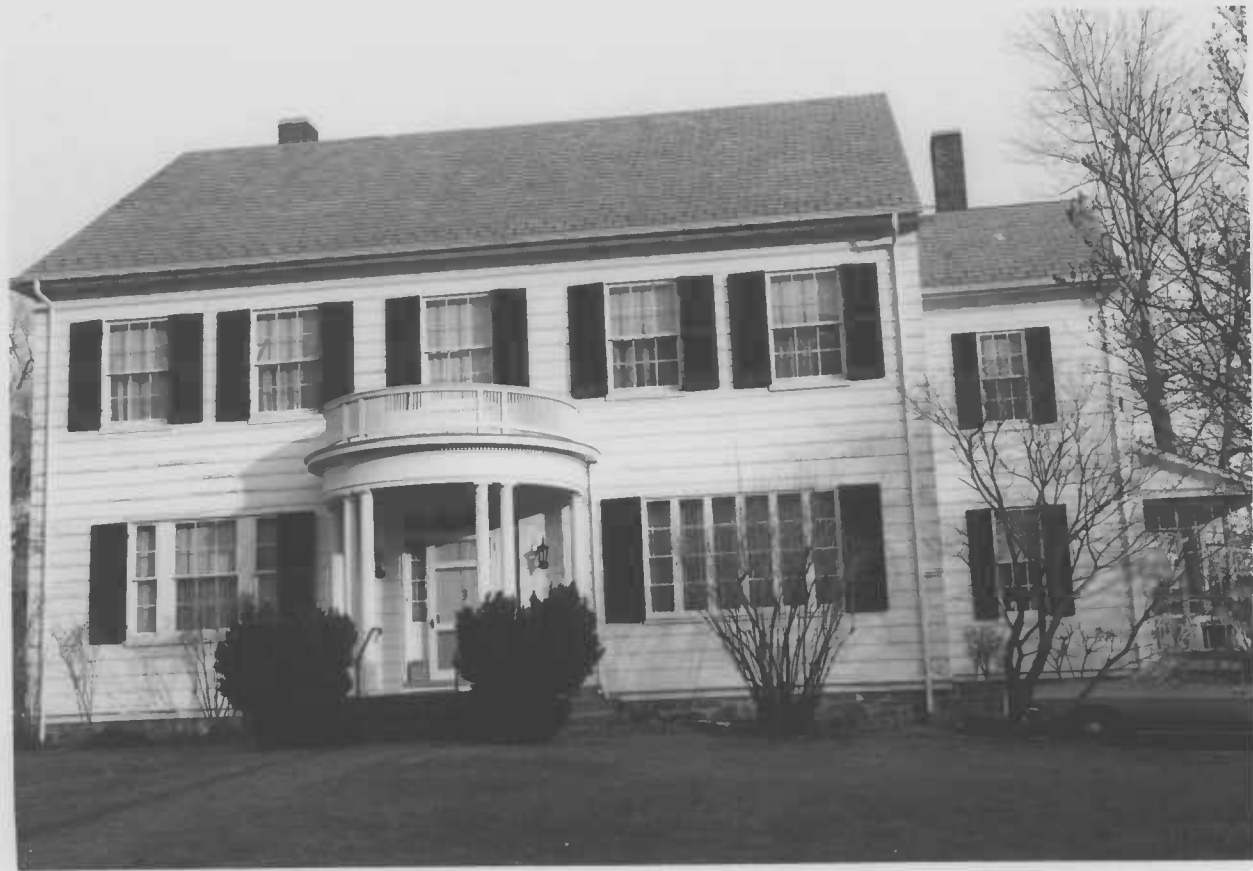
CRAUMER HOUSE
W. FACADE

Looking at the west or main facade, which has a brick lane leading toward it, one immediately sees the balance and symmetry that is typical of Neo-Colonial structures. The functional entrance is centrally located. The door is plain wood topped with a transom window and flanked by sidelights. These allow the central hallway to have sufficient natural lighting. Directly above the doorway is a semi-circular bay portico with a plain frieze and dentals. This structure is supported by six truncated Doric columns - two pairs on either side of the door and two single columns located on the furthest most ends. Two lanterns are located on either side of the entrance.

The original stone foundation and basement are still intact. The windows on the west facade are symmetrically placed. There are five 6/6 windows on the second story. On the first story there are two large windows on either side of the entrance. To the north of the entrance is a 6/6 window bound by a 2/2 window on either side. To the south of the entrance is a large 12/12 window. All of the windows have functional shutters. A decorative fan-shaped window can be seen on the south facade. The porch on the south facade remains much the same as it had been in 1895. (See earlier description.)

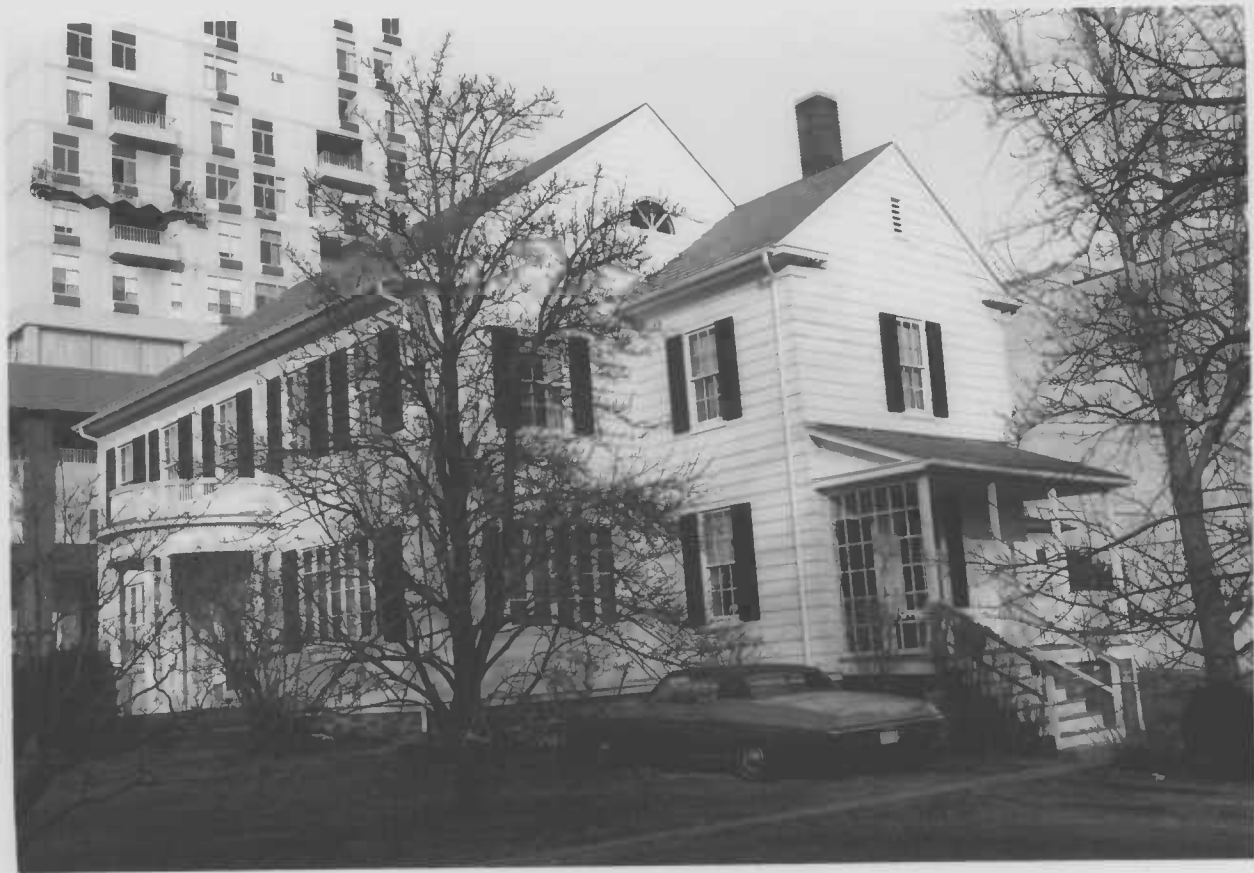
CRAUMER HOUSE

The south wing had a porch winding around the southwest corner. The porch was supported by turned columns, had ornate gingerbread brackets and German siding. Extensive lattice work was present underneath the porch. The foundation of the structure was and still is stone with a full stone basement. The foundation has a rise of 32" at a grade. The entrance to the basement is located on the south side underneath the porch.

S.W.
